## HASLEMERE TOWN COUNCIL

## Resurfacing of the zip wire runway

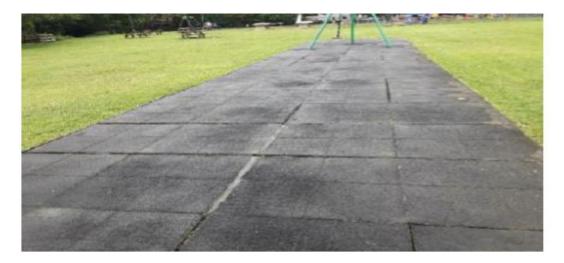
- We instruct an independent inspector to undertake a quarterly inspection of our play equipment and surfaces.
- The original surface, which is a tiled Wetpour, has previously been considered low risk but has now been downgraded to moderate risk because of the shrinkage between the tiles and increasing signs of wear and damage.

Wetpour tiled surface at Lion Green

**<u>RECOMMENDATION</u>**: The zip wire surface is completely replaced with a bonded rubber mulch, with the cost being added to the budget for 2024/2025.
