## HASLEMERE TOWN COUNCIL

## Resurfacing of the zip wire runway

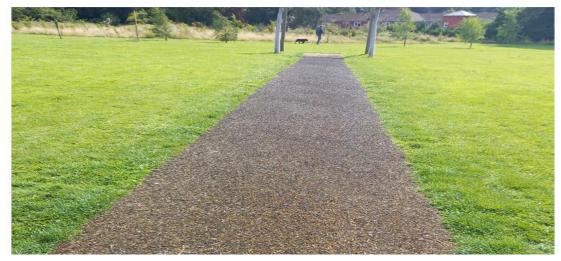
Bonded mulch surface at Easebourne

**<u>RECOMMENDATION</u>**: The zip wire surface is completely replaced with a bonded rubber mulch, with the cost being added to the budget for 2024/2025.
